SAFETY INVESTIGATION REPORT

REPORT NO.: 11/2016

MY AKALAM

Grounding while on passage From Giardini Naxos to Messina, Sicily 08 July 2015

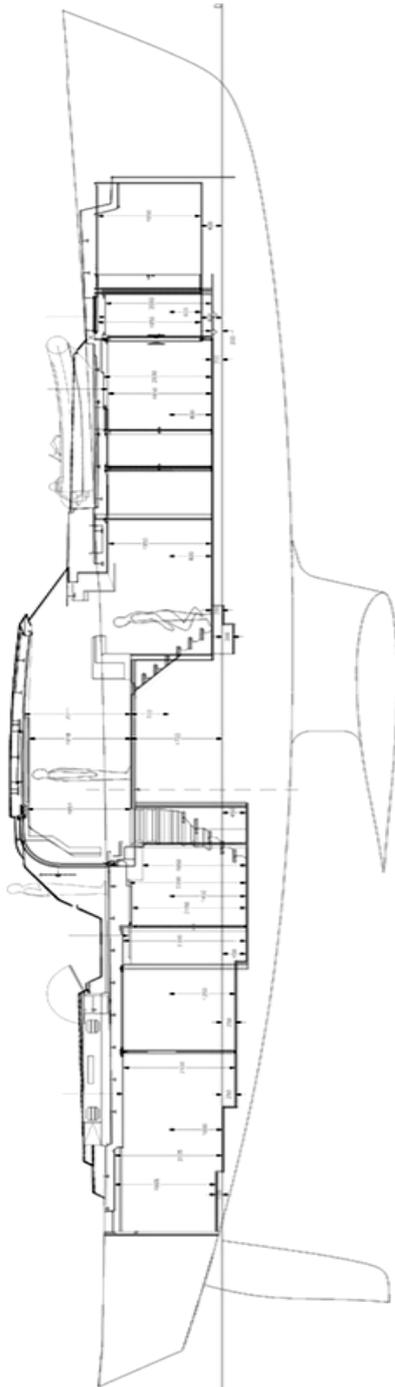
Figure 1: MY *Akalam* GA Plan

Motor/sail yacht *Akalam* (Figure 1) is a 32 m sloop built in 2011 at Pendennis Shipyard, Falmouth, UK. The hull and superstructure are built of aluminium and fitted with a 610 bhp MAN engine, giving speeds in excess of 13.50 knots. Under sail, she is capable of reaching 11 knots in 20 to 25 knots wind.
