## 1. FACTUAL INFORMATION

### 1.1. History of the flight

On 2 January 2012, a Cirrus SR22 aircraft, registration N217ET, was on a private flight with one person onboard between the Mallorca Son Bonet Airport (LESB) in Spain and the Toussus-le-Noble Airport (LFPN) in France. A Beechcraft 90 King Air, registration PH-KBB, was on an instructional flight with two persons onboard, having taken off from the Rotterdam Airport in the Netherlands (EHRD), with destination to the Girona Airport (LEGE) in Spain.

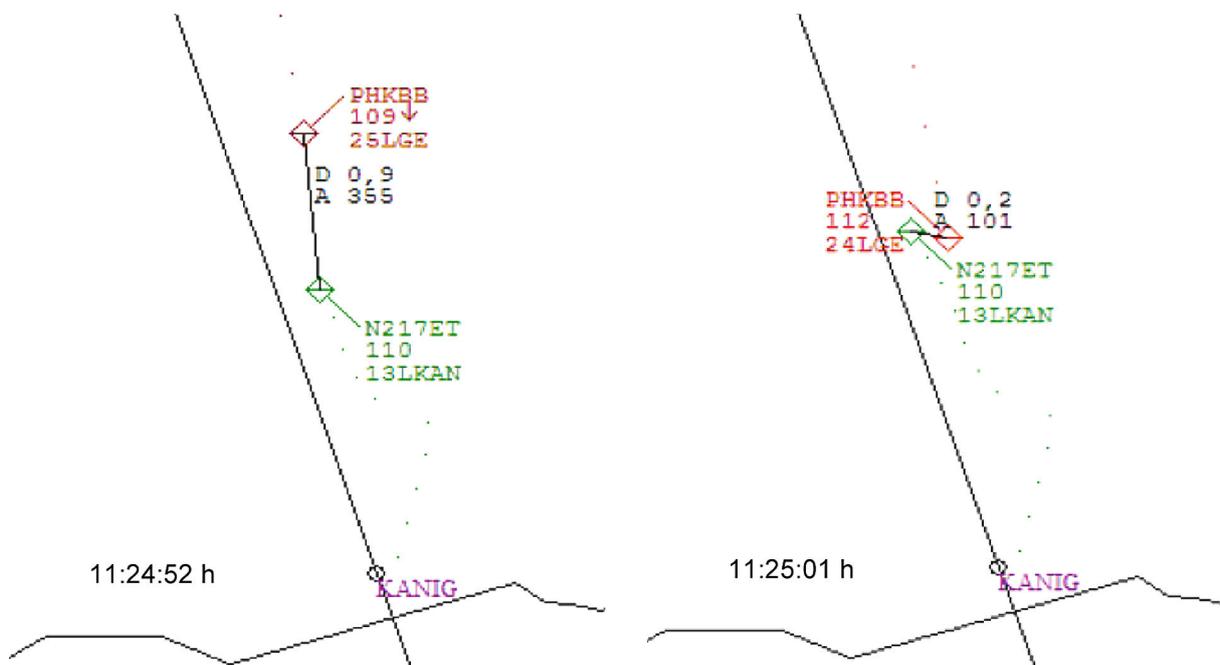
At 11:25:01 h the two aircraft crossed each other at FL110, separated by a vertical distance of 200 ft and a horizontal distance of 0.2 NM. Aircraft PH-KBB had descended from the flight level authorized by ATC (FL120) because, according to its crew, it had been cleared by ATC to FL90.

The aircraft were 2 NM north of reporting point KANIG, formally in French air space but under Spanish air traffic control (Barcelona ACC Sector T1).

Figure 1. Crossing of aircraft PH-KBB and N217ET
