DATA SUMMARY

Date and time	Wednesday, 8 February 2012; 08:30 local time¹
Site	Approach to the Barcelona Airport (Spain)

Registration	OO-SSR	EC-HAG
Type and model	AIRBUS A-319	AIRBUS A-330-214
Operator	Brussels Airlines	Iberia

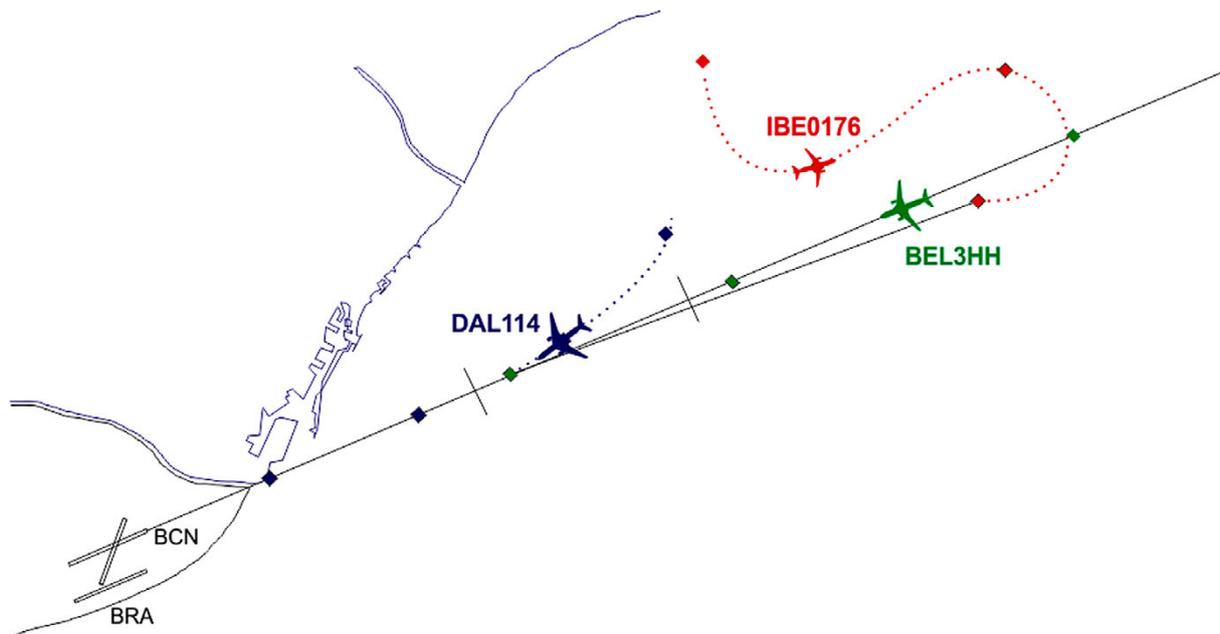
As a result the order was changed and IBE0716 was rerouted left to place it behind BEL3HH in the landing sequence. The TCAS RA warning took place while IBE0716 was turning (see Figure 1).

Figure 1. Position of the three aircraft at the time of the TCAS warning

To divert IBE0716’s flight path, the controller made it turn left without taking into account the fact that this airplane was 3 NM away from the localizer and that turning would put it on an intercept course with BEL3HH.

At the same time, the controller asked BEL3HH to descend to 2,300 ft and IBE0716 to maintain 4,300 ft without realizing that BEL3HH was about to reach 4,000 ft, meaning they were not only on intercept courses but they would be at the same altitude as well.

If the controller had instructed IBE0716 to turn right and maintain altitude, or had he taken out the BEL3HH traffic instead of the Iberia one, the airplanes’ courses would have diverged instead of converged.

The resolution of the conflict was not adequate. Once it was decided to have IBE0716 turn, this aircraft shouldn't have been allowed to turn left without taking into account the altitudes of the aircraft or their possible converging flight paths. It would have been better handled by making IBE0716 turn right.
