DATA SUMMARY

Date and time	Saturday, 13 April 2012; 20:17 UTC
Site	Seville Airport (LEZL) (Spain)

Registration	EI-EBA	EI-EVC
Type and model	BOEING 737-8AS	BOEING 737-8AS
Operator	Ryanair	Ryanair

REPORT

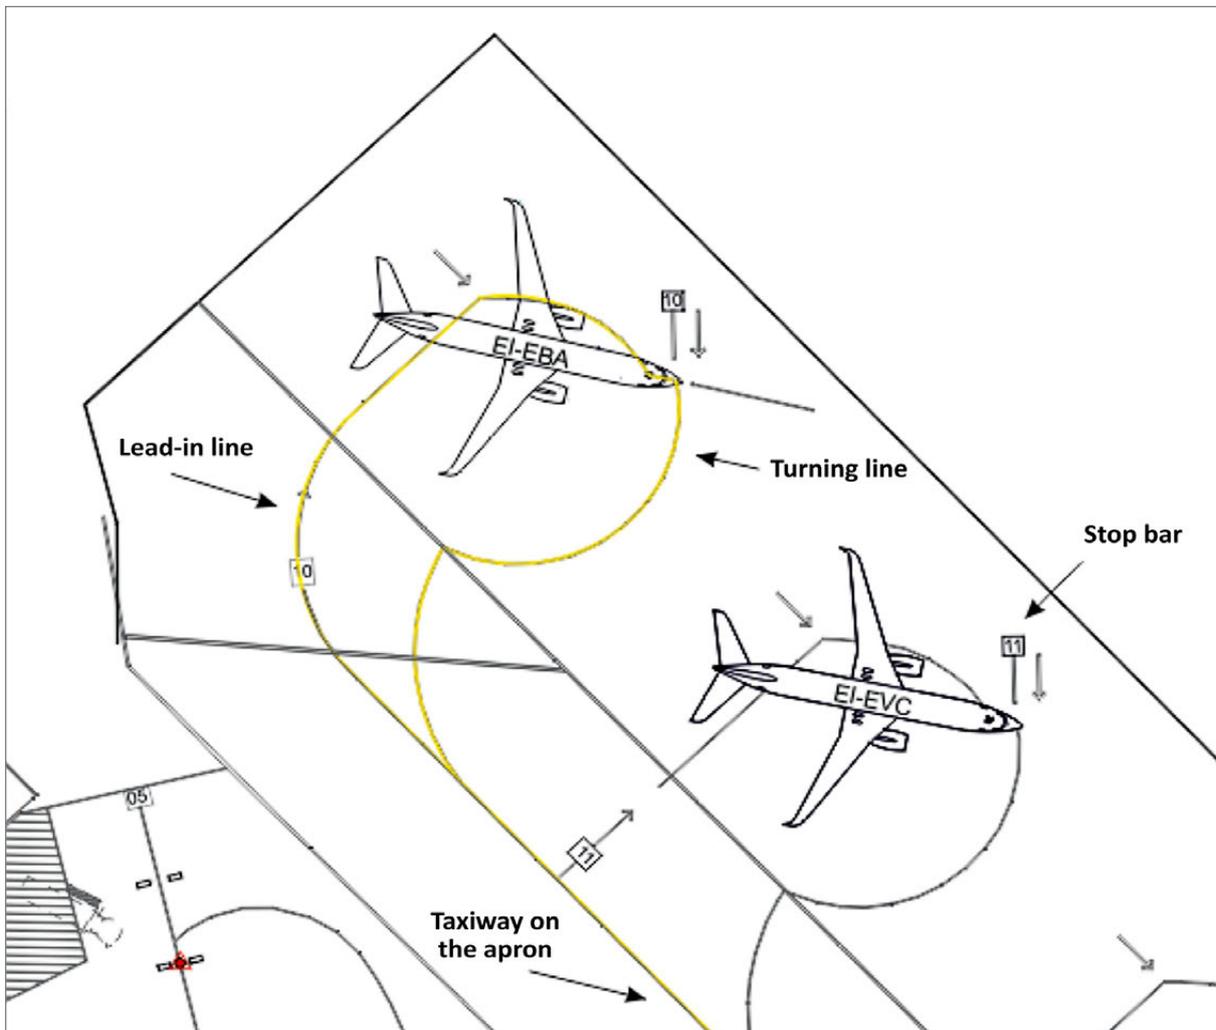
Figure 1. Parking stands R10 and R11

On 13 April 2012, two Boeing 737-800 aircraft, registrations EI-EBA and EI-EVC, operated by Ryanair, were stopped at parking stands R10 and R11, respectively, at the Seville Airport.

the aid of the ramp coordinator on the ground, the pilot in command started to taxi from position R10 along the turning line to proceed to taxiway G-8. Aircraft EI-EVC, on stand R11, had completed boarding its passengers and its doors were still open.

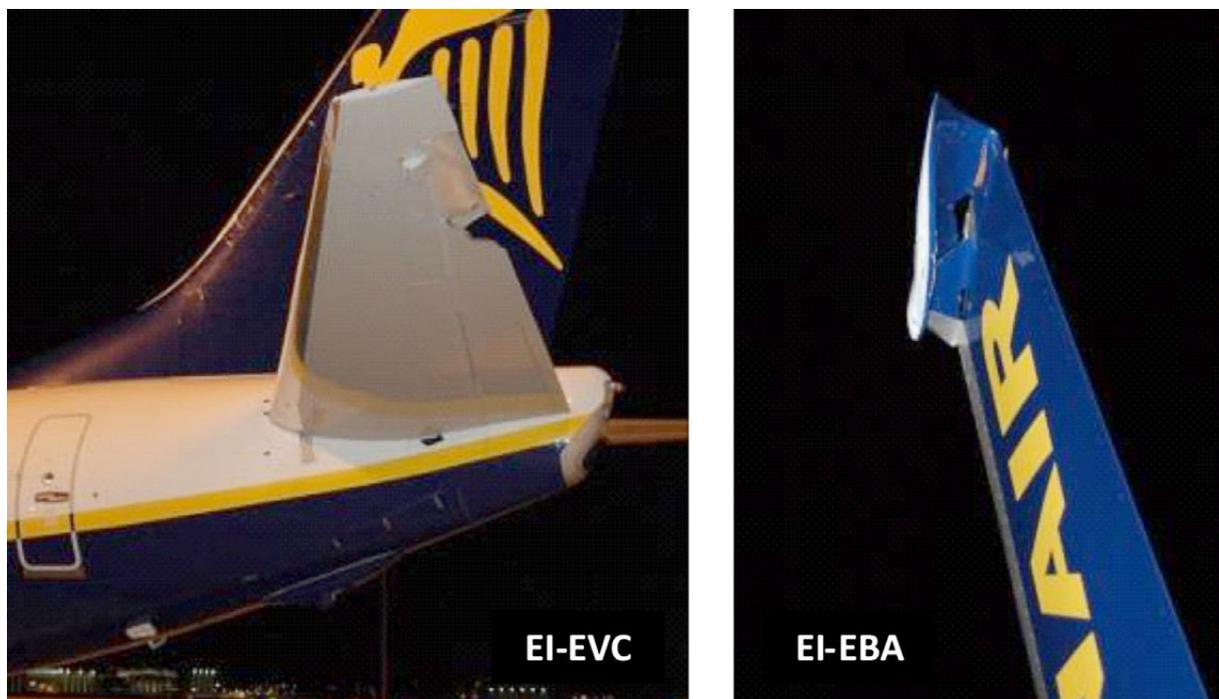
Figure 2. Damages

As aircraft EI-EBA was moving over the turning line, it departed said line before fully traveling over its length and proceeded directly toward the taxiway on the apron. Before reaching the taxiway, its left winglet struck the left horizontal stabilizer and elevator on aircraft EI-EVC. The damage caused by the impact, see Figure 2, prevented either aircraft from continuing with its scheduled flight.

The 737-8AS aircraft, registration EI-EBA, started to taxi from parking stand R10 along the turning line so as to enter taxiway G-8. As it was doing so, its left winglet struck the left horizontal stabilizer and elevator of the aircraft parked in the adjacent stand, resulting in neither aircraft being able to continue with its flight.

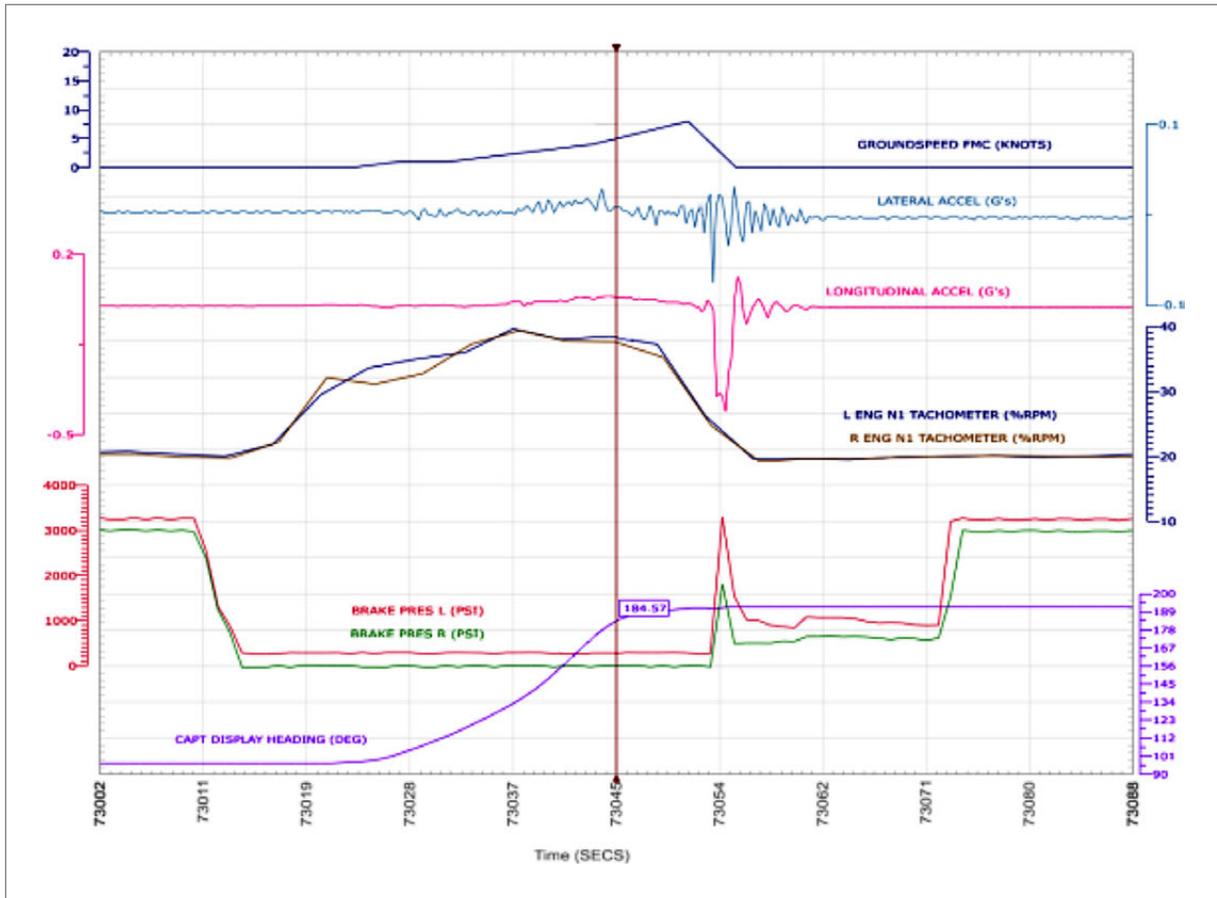
Figure 3. DFDR parameters from aircraft EI-EBA

Aircraft EI-EBA and EI-EVC were equipped with flight data and cockpit voice recorders. Figure 3 shows the various parameters recorded by the DFDR² on aircraft EI-EBA as it taxied on the apron.

The recorded flight data provided information on the path taken by the aircraft from the start of the taxi phase to the turning line. These data show a change rate in the heading of around 7° per second up to a value of approximately 185° , at which point the turn rate decreased to approximately 1° per second.

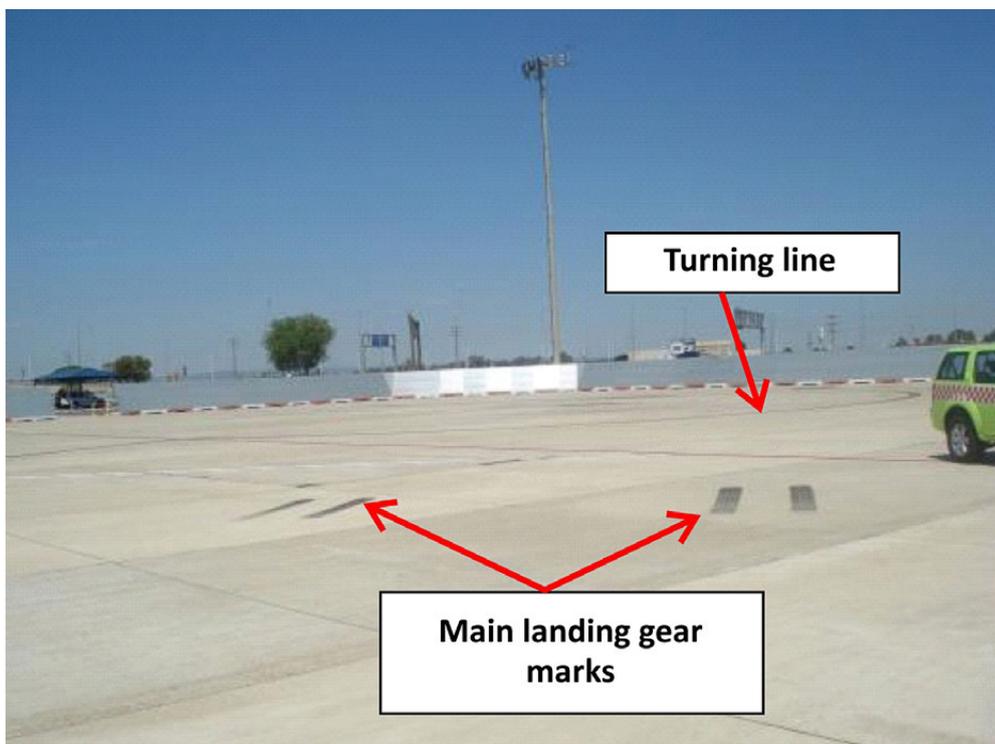
Figure 4. Marks

The position of the main landing gear was indicated on the apron surface by the braking mark, which established the aircraft's final position after making contact with the aircraft parked at correctly stand R11.

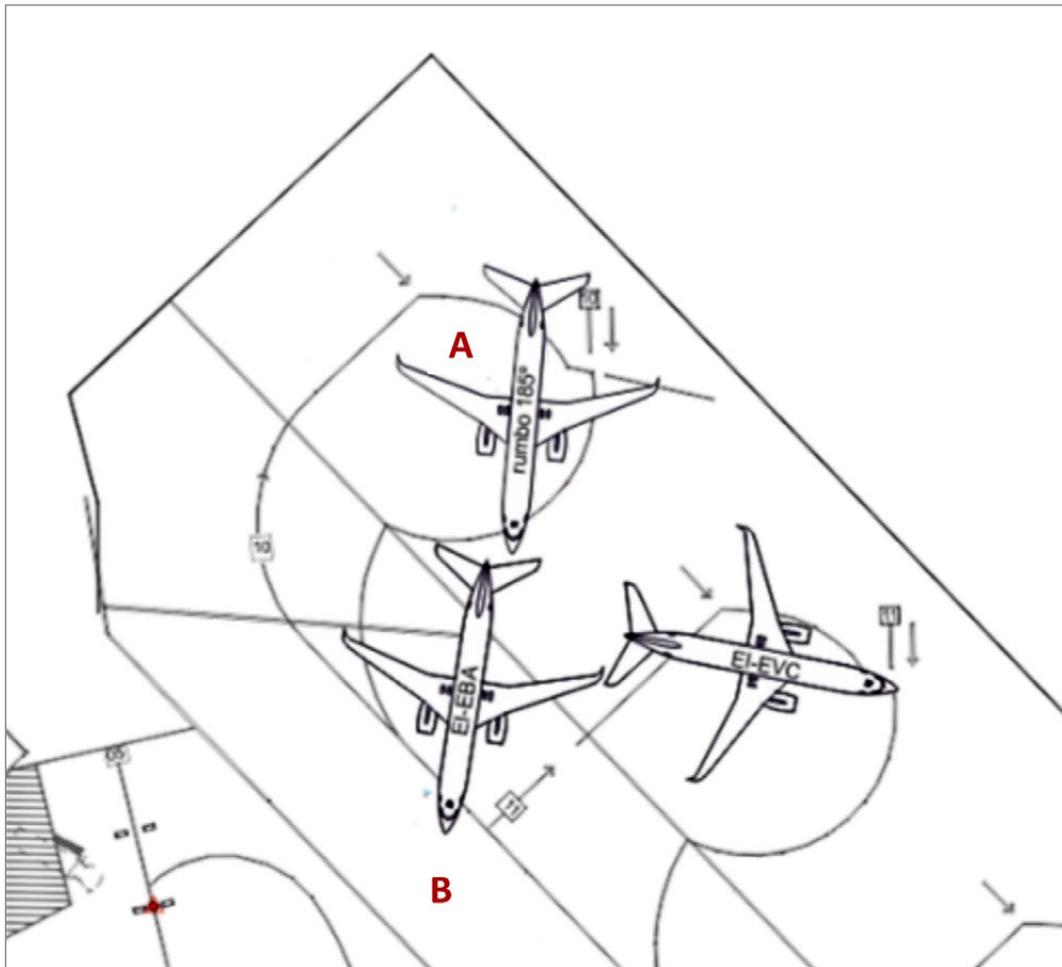
Figure 5. Positions of the aircraft

Figure 5 shows the position (A) occupied by the aircraft when it was on a heading of 185° and the position (B) where it stopped.

As regards the taxi maneuver of the aircraft, a simulation of the path it took over the turning line, as reconstructed from recorded data, showed that it left the turning line before completing it, as shown by position A in Figure 5. Position B in this same figure shows the location of the aircraft as indicated by the braking mark left by the main landing gear wheels.

The incident was caused by aircraft EI-EBA not following the turning line all the way-out of parking stand R10.
