DATA SUMMARY

Date and time	Friday, 1 June 2012; 16:45 local time¹
Site	Benagéber Reservoir (Valencia, Spain)

Registration	EC-KRF
Type and model	AIR TRACTOR AT802A amphibious
Operator	Avialsa T-35, S.L.

Date of approval	24 July 2013
------------------	---------------------

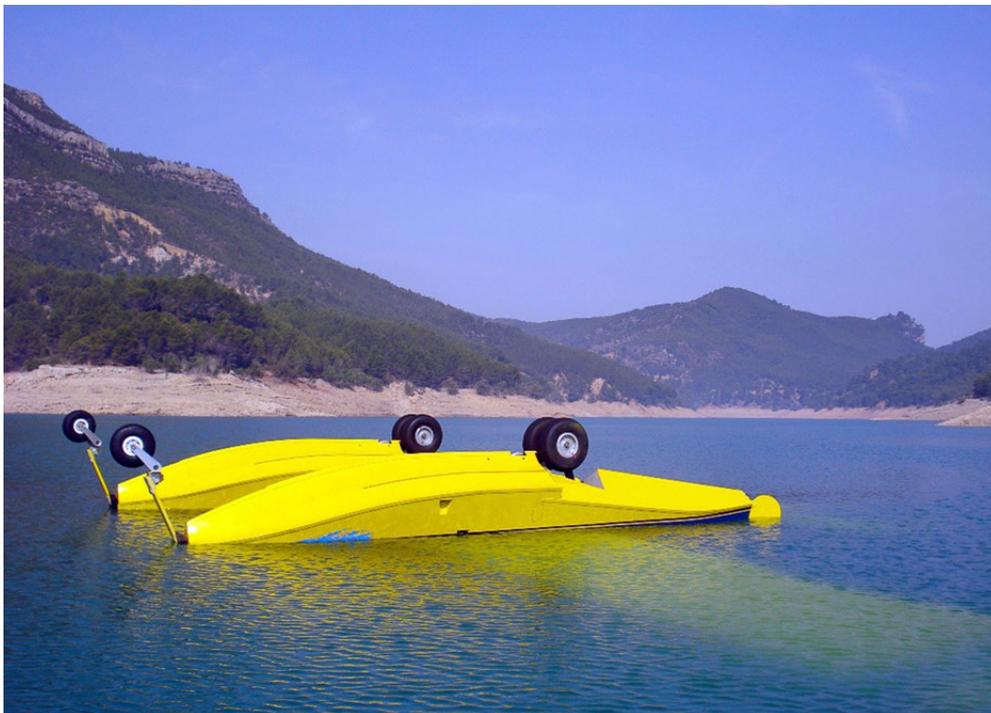
The aircraft was towed to shore and lifted out with the help of a crane. It was placed upright on its landing gear. The gear was fully down and locked. There was significant damage to the aircraft, especially along its front section.

Figure 1. Condition of the aircraft after the accident

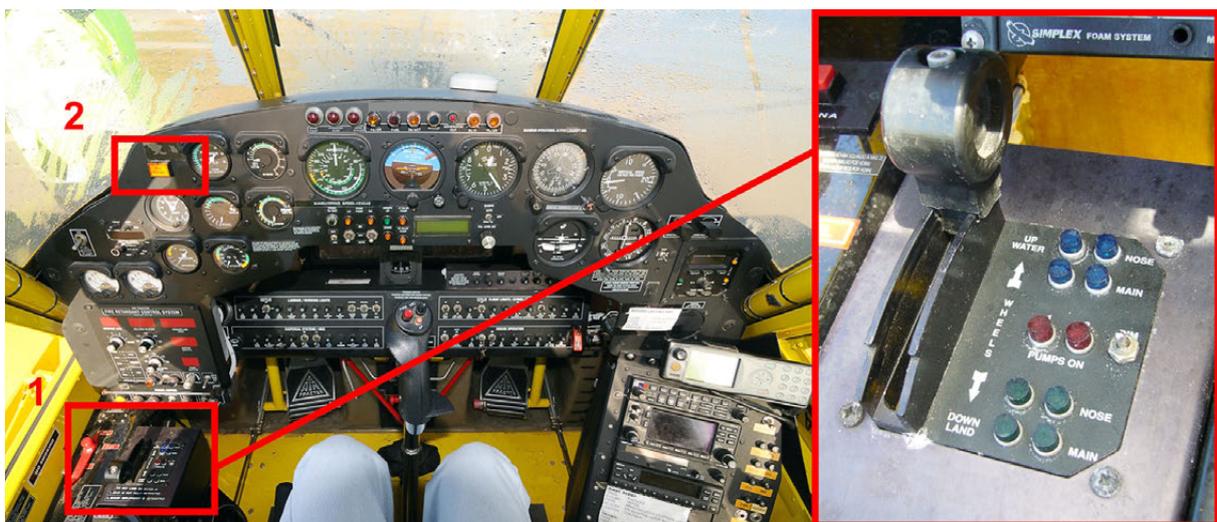
The gear is not visible from the cockpit, so the aircraft has the following visual and aural gear position indication systems (Figure 2):

- Down and to the left, on a flat panel parallel to the floor, a set of 10 position lights next to the gear lever (1 in Figure 2):
 - 4 blue lights that are on when the gear is up and locked,

- 2 red lights that are on when the pumps are on, meaning the gear is in transit, and
 - 4 green lights that are on when the gear is down and locked.
- An acoustic gear advisory every 3.5 seconds that, when the airplane's speed drops below a certain value set by the operator above a certain minimum, informs the pilot on the position of the gear:

- Up and to the left is an amber GEAR ADVISORY light (2 in Figure 2) that turns on along with the preceding acoustic advisories. If the pilot flips this switch, the acoustic message stops.

Figure 2. Location of visual gear indications in the cockpit of the AT802A

Therefore, as concerns the aircraft's technical systems and improper gear configurations, the design of the gear actuation and indication system is regarded as providing a counterintuitive indication of the gear's position. It is also in a part of the cockpit that is not visible. The Gear Advisory system is regarded as employing elements that are easily discernible (male-female voice) that should be effective as long as the activation speed is properly set.

REC 43/13. It is recommended that Air Tractor, considering the safety consequences of an improperly positioned landing gear during scooping operations, improve the design of the actuating, indication and/or gear advisory landing gear system, in order to advise the pilot of improper position of the landing gear.

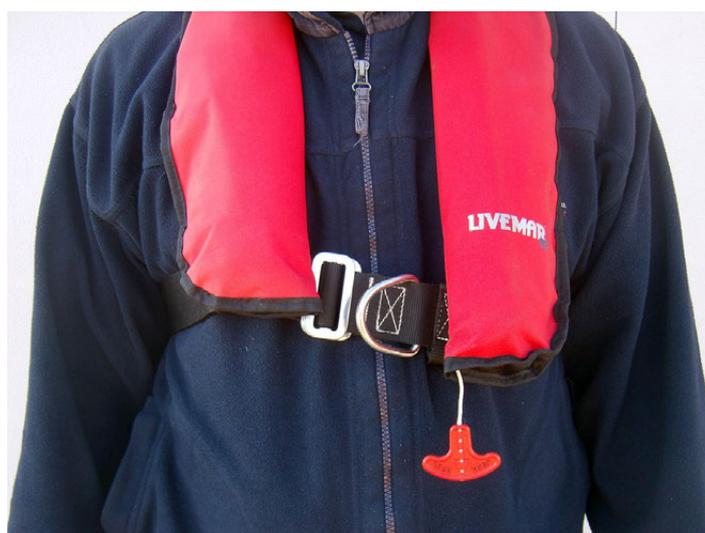
The pilot was wearing a LIVEMAR life vest (Figure 3). It has two parts: an internal yellow part that inflates, and covering this part a red portion with harnesses used to fit the vest to the body. The vest is manually inflated by pulling on a tab that hangs some 5 centimeters below the bottom edge of the vest. The vest's specifications are as follows: "150N, Inflatable lifejacket ISO 12402-3" for the inflatable part and "Deck safety

Figure 3. Life vest used by the pilot in this accident

Harness Conforms to ISO 12401” for the harness. The vest does not make any reference to any certification standard for aviation vests (TSO or ESTO).

The life vest is required by both the operator and by Spain's Air Traffic Regulations (RCA). The certification standard specifies that it must be an approved vest. The one worn by the pilot was not approved by any aviation certification standard and is the one used in maritime operations.

When the vest worn by the pilot was compared with vests certified by aviation standards, however, it was noted that some models have the same vest inflation mechanism. This means that even if the pilot had been wearing a TSO-C13F or ETSO-72c certified vest that relied on the same inflation mechanism, he would have had the same problem and the vest would have inflated.

Thus due to the gravity of the situation that resulted, a safety recommendation is issued so that in aircraft with small cockpits, like the one in the accident airplane, life vests are used whose actuation mechanism is not susceptible to getting hooked and inadvertently actuating.

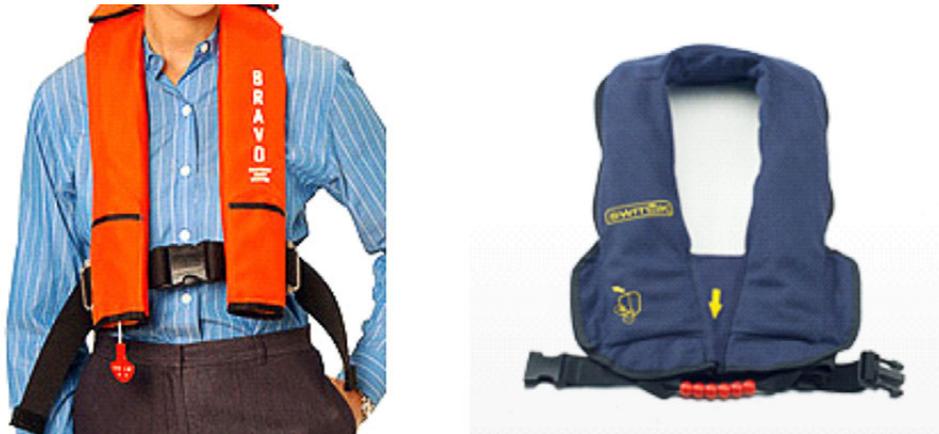
Vests certified as per TSO-C13f and having a design similar to the one worn by the accident pilot are shown in Figure 4. The orange vest on the left, for example, is used by another operator of this type of aircraft. The inflation mechanism is identical to that on the vest worn by the accident pilot (see Figure 3). The blue vest on the right has a different inflation system and is also TSO-C13f certified.

Figure 4. Other models of TSO-C13f certified life vests
