DATA SUMMARY

Date and time	Saturday, 24 August 2012; 18:43 local time
Site	Guils de Cerdanya (Girona)

Registration	EC-KTU
Type and model	EUROCOPTER AS-350-B3
Operator	TAF Helicopters, S.L.

Operation	Aerial work – Commercial – Firefighting
Phase of flight	Maneuvering – Low-altitude flight

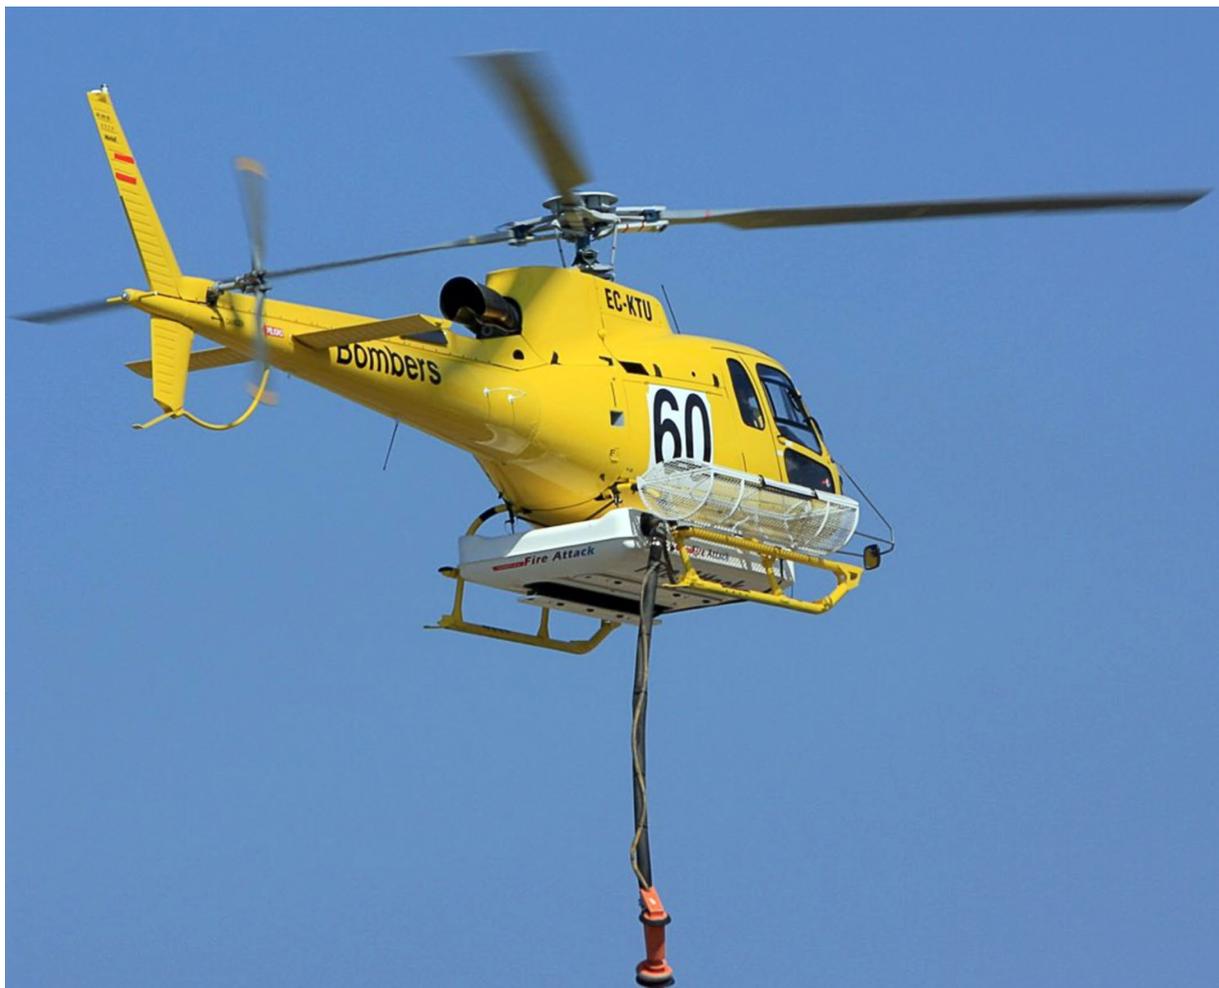
The helicopter was equipped with a firefighting system that consisted of a belly tank for transporting water and a hose with a suction pump hanging down from the side of the tank. Part of the hose and the pump were hanging 3.25 m below the right skid.

Figure 1. Helicopter with the Simplex 310 firefighting system attached

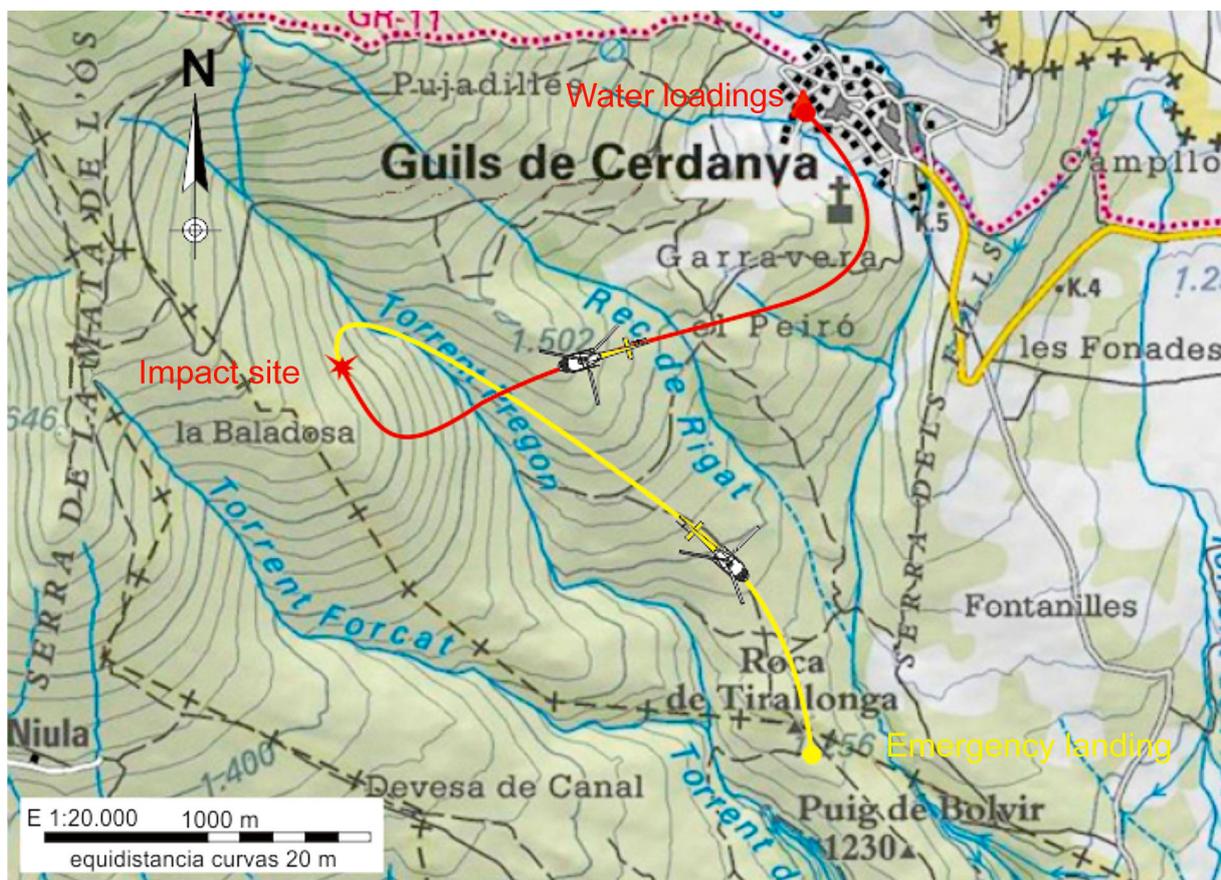
On the accident drop and on the preceding one, the helicopter loaded water at a pool in the town of Guils de Cerdanya, located NE (Northeast) of the fire and two kilometers away. On these last two drops the helicopter worked in concert with the firefighting squad mentioned earlier. The fleet tracking equipment used by the regional government of Catalonia was used to determine the flight path taken by the helicopter from the town and the fire, as shown in Figure 2.

The helicopter was flying over very positively sloped terrain just prior to the water drop.

Figure 2. Route taken on last water drop and water loading, impact and landing sites
