SUMMARY

Grounding of MV *BEAUMONT* Cabo Negro, Spain 12 December 2012

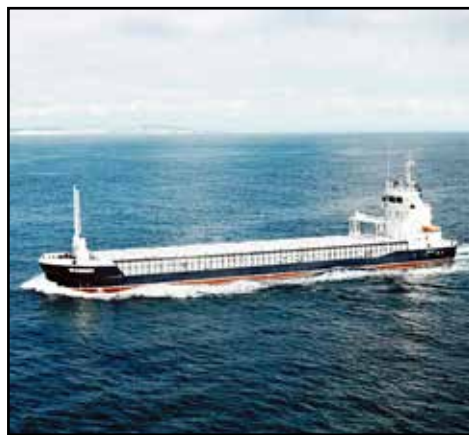
An inspection of the vessel's internal compartments quickly established that, despite being driven hard aground on a rocky ledge, there was no breach of the hull. Nine hours later, with the assistance of a salvage tug, *Beaumont* was successfully refloated and continued to Avilés under her own power, where she was further inspected before departing for a repair yard.

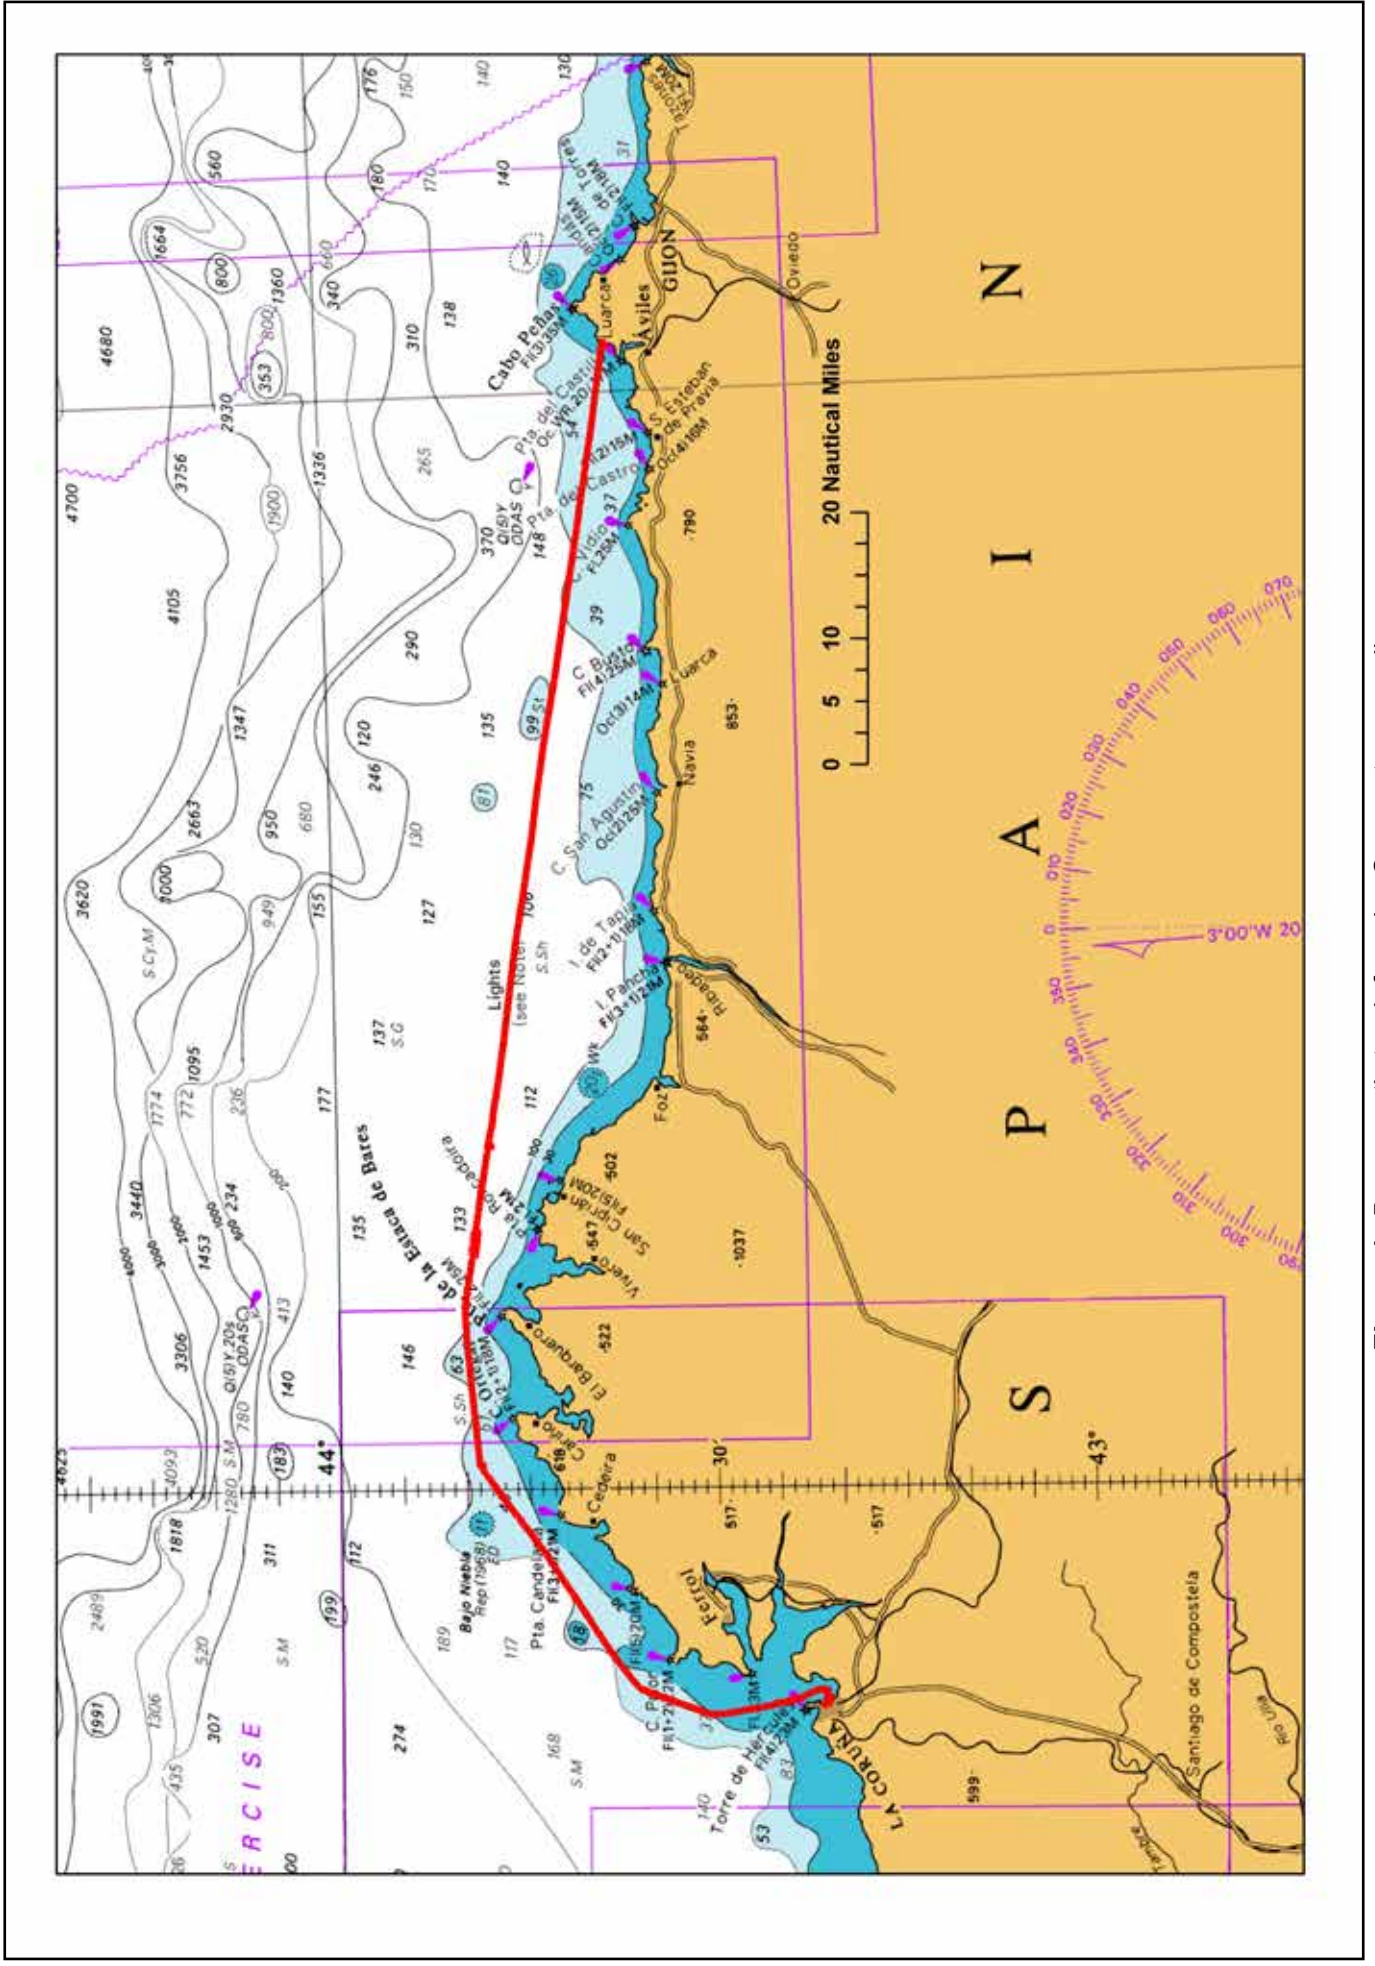
Figure 1: Beaumont's track from La Coruna to grounding

At 0308 UTC on 12 December 2012, the dry cargo vessel *Beaumont* ran aground on Cabo Negro on the north Spanish coast while on passage from La Coruña to Avilés (**Figure 1** overleaf). At the time of the grounding she was proceeding at full speed, and the officer of the watch (OOW) was asleep.

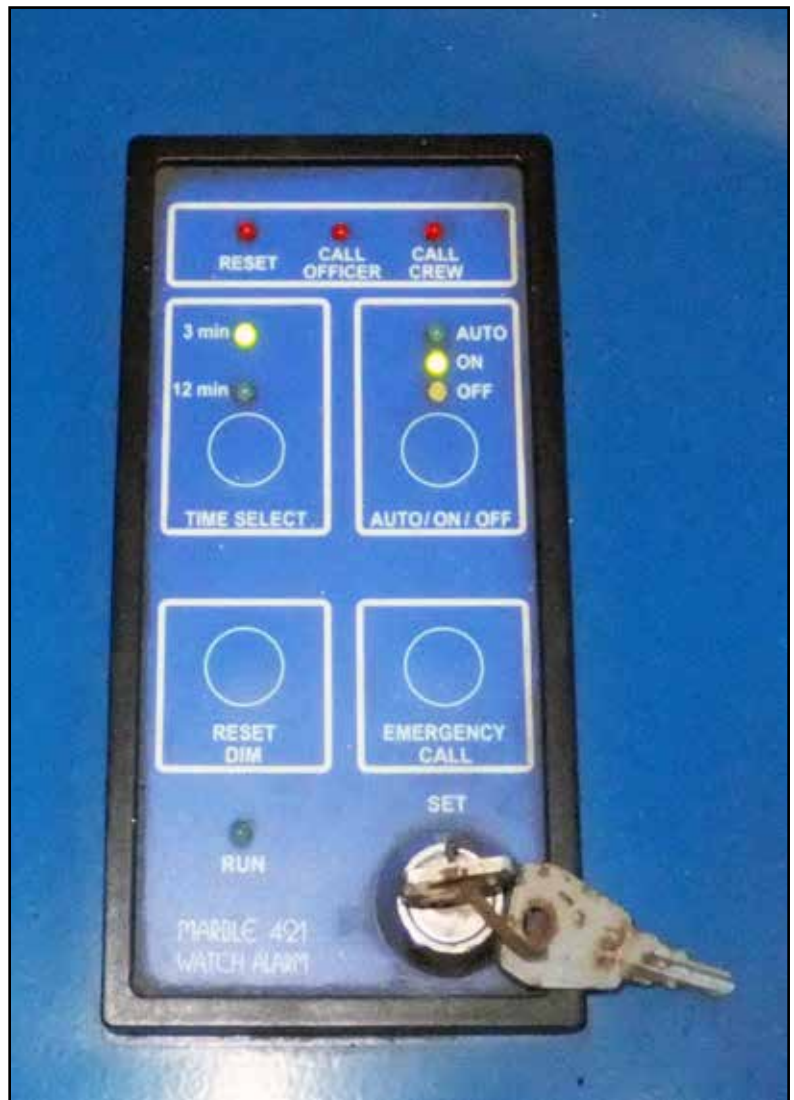
Figure 2: Bridge navigation watch alarm system's control

Notwithstanding the benefits of these systems, it is possible that the chief officer could have slept through these alarms, given the depth of his slumber. However, though not required by regulation at the time of the accident, *Beaumont* was also equipped with a BNWAS. This device was specifically designed and fitted to alert or draw attention to an incapacitated OOW. However, the vessel's managers did not specifically require the BNWAS to be in operation at sea and consequently it was seldom, if ever, used by the bridge watchkeepers.

- Navigational aids were not used effectively to ensure a vigilant and effective watch was maintained at all times.
- The vessel was equipped with a BNWAS. However the ship's managers did not require that this equipment was used at sea and it was seldom, if ever used by the bridge watchkeepers.

- Revised its SMS to require:
 - The use of lookouts during the hours of darkness
 - The use of radar and echo sounder alarm facilities
 - The use of BNWAS when vessels are underway.

- Paper charts are used as the primary means of navigation.
- Where technically possible, linked BNWAS systems with autopilots so that the watch keeping alarm is operational whenever the autopilot is in use.
