INFORME CIAIM-06/2021

PINAR DEL RIO's ship grounding in the entrance of the port of Denia (Alicante), 16 August 2019

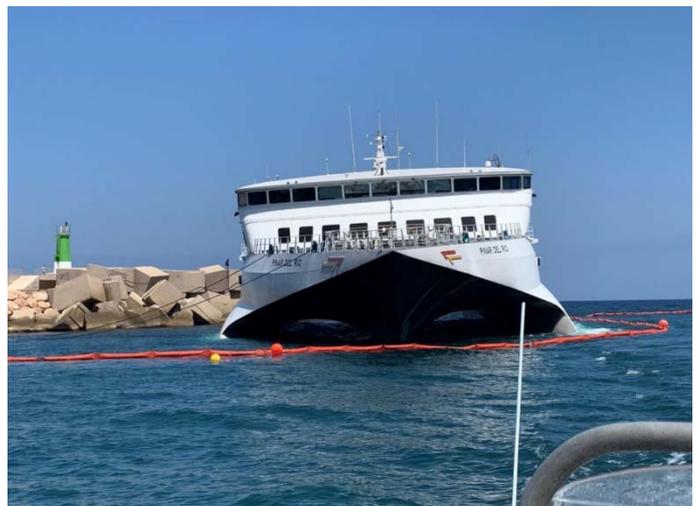
Figura 3. The ship Pinar del Rio at the accident site

The ship's position was stabilised by securing the manoeuvring ropes to the concrete blocks of the breakwater. The ropes were reinforced with wires in the days after the incident (see Figura 3).

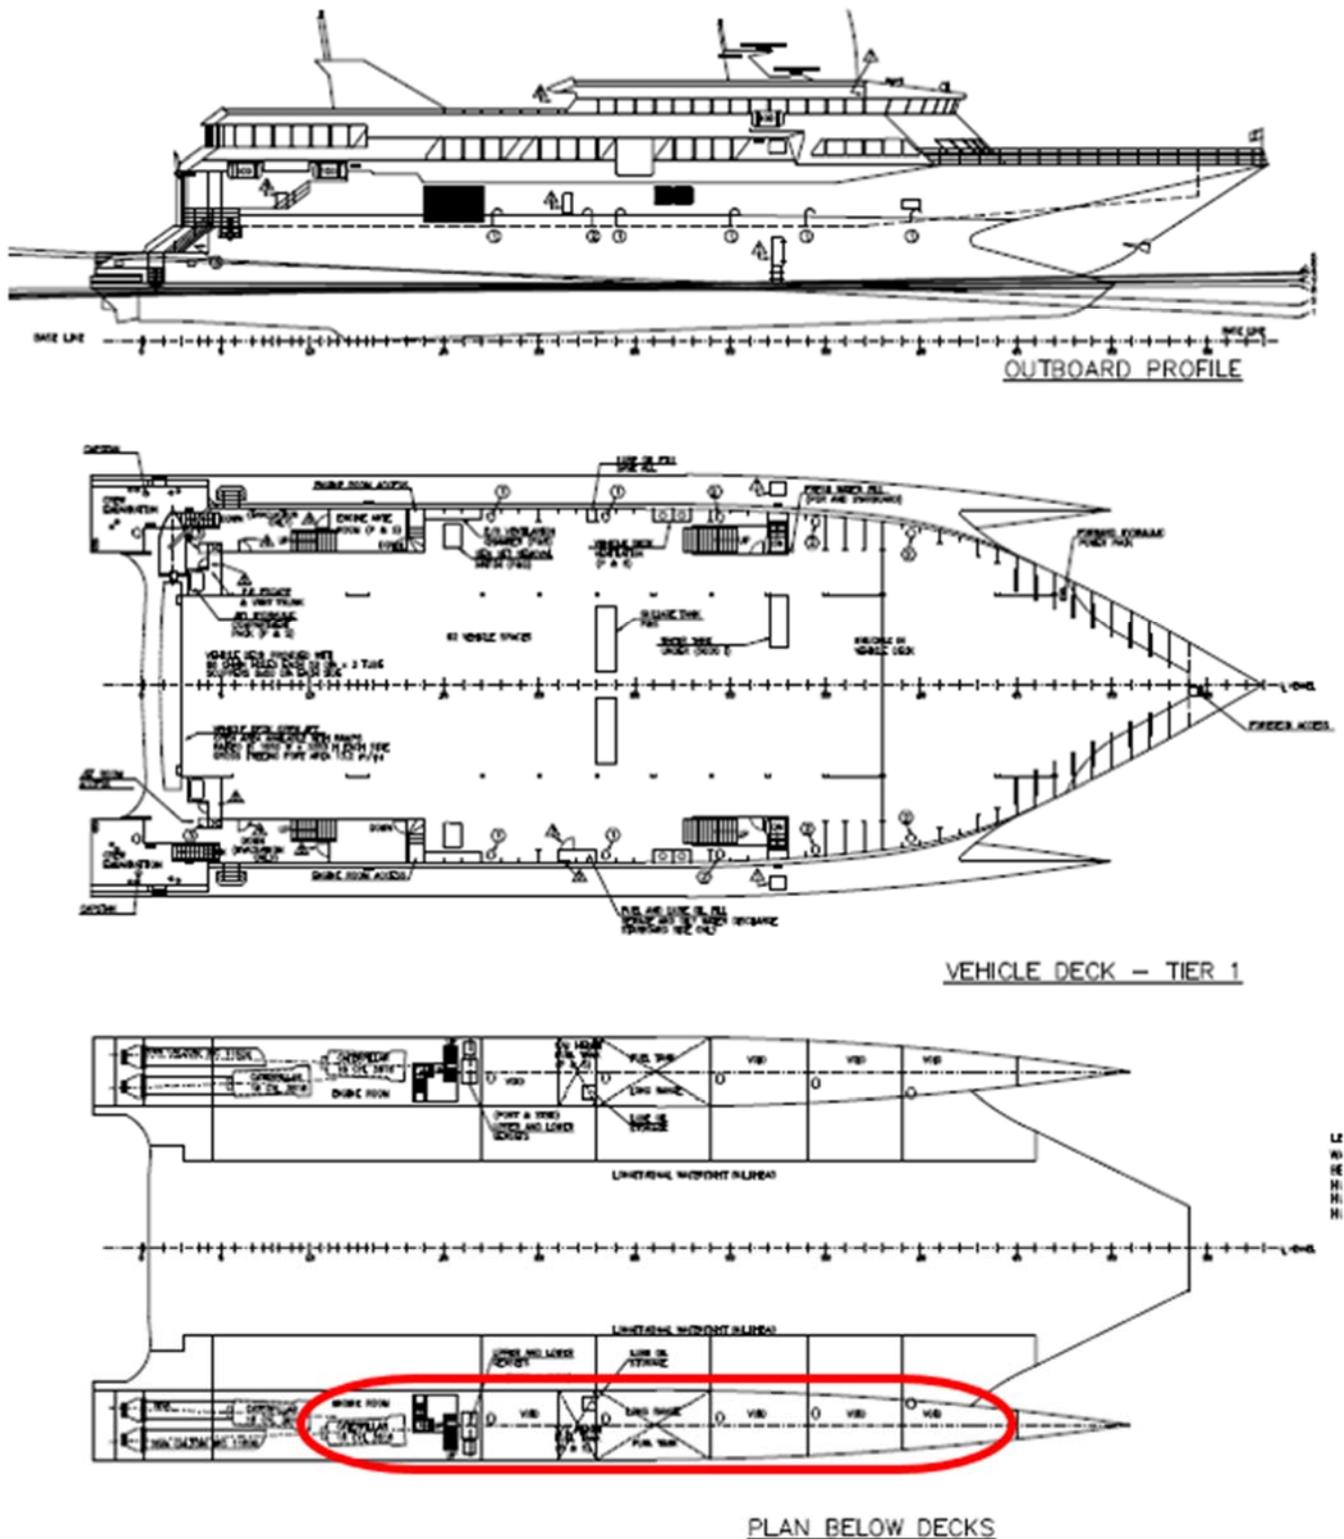
That morning, a specialist underwater works firm hired by the company carried out an inspection to assess the magnitude of the damage. The ship was resting on a cubic concrete block in the area between hull void No. 5 and the engine room. No oil spill was detected.

Figura 4. Location of damage to the starboard hull of the ship PINAR DEL RIO

As a result of the accident, the ship PINAR DEL RIO incurred significant damage to its starboard hull, specifically, the deformation, breakage and loss of aluminium panels and structural elements in voids No. 1, 2, 3, 4 and 5, and the engine room (see Figura 4). In addition, the flooding in the engine room caused the failure of the propulsion engines and other critical equipment.

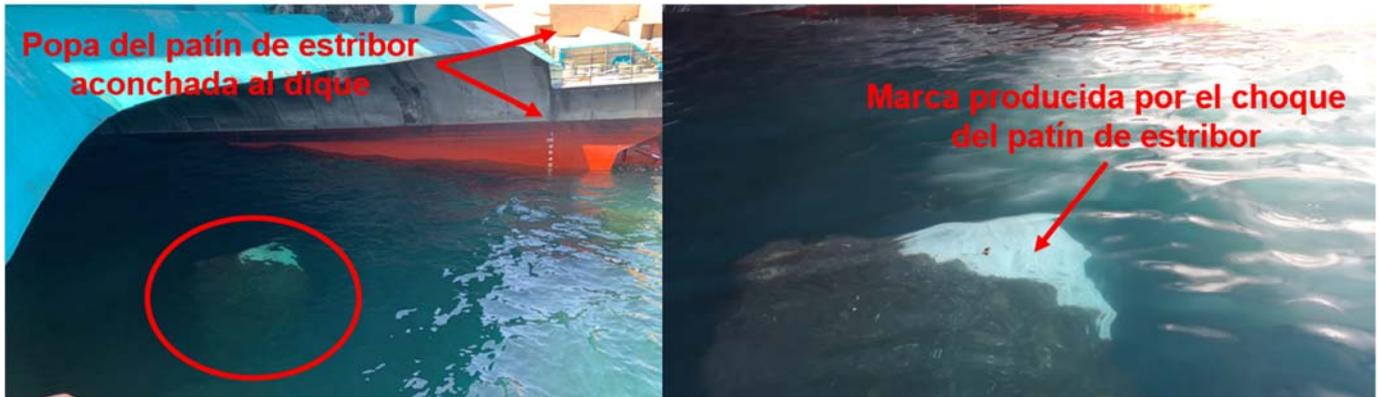
At first glance, it seemed the ship was on course to clear the breakwater on the surface, but this assessment was misleading. The dock is built on a slope, using concrete blocks stacked on the breakwater to dissipate the energy of the waves. Some of the blocks are located just below the sea's surface but several metres away from where the

breakwater appears above the waterline. As a result, vessels must steer well clear of the breakwater and stay within the designated channel when navigating in and out of the port (see Figura 5).

Figura 5. Concrete block that caused the ship PINAR DEL RIO to run aground.

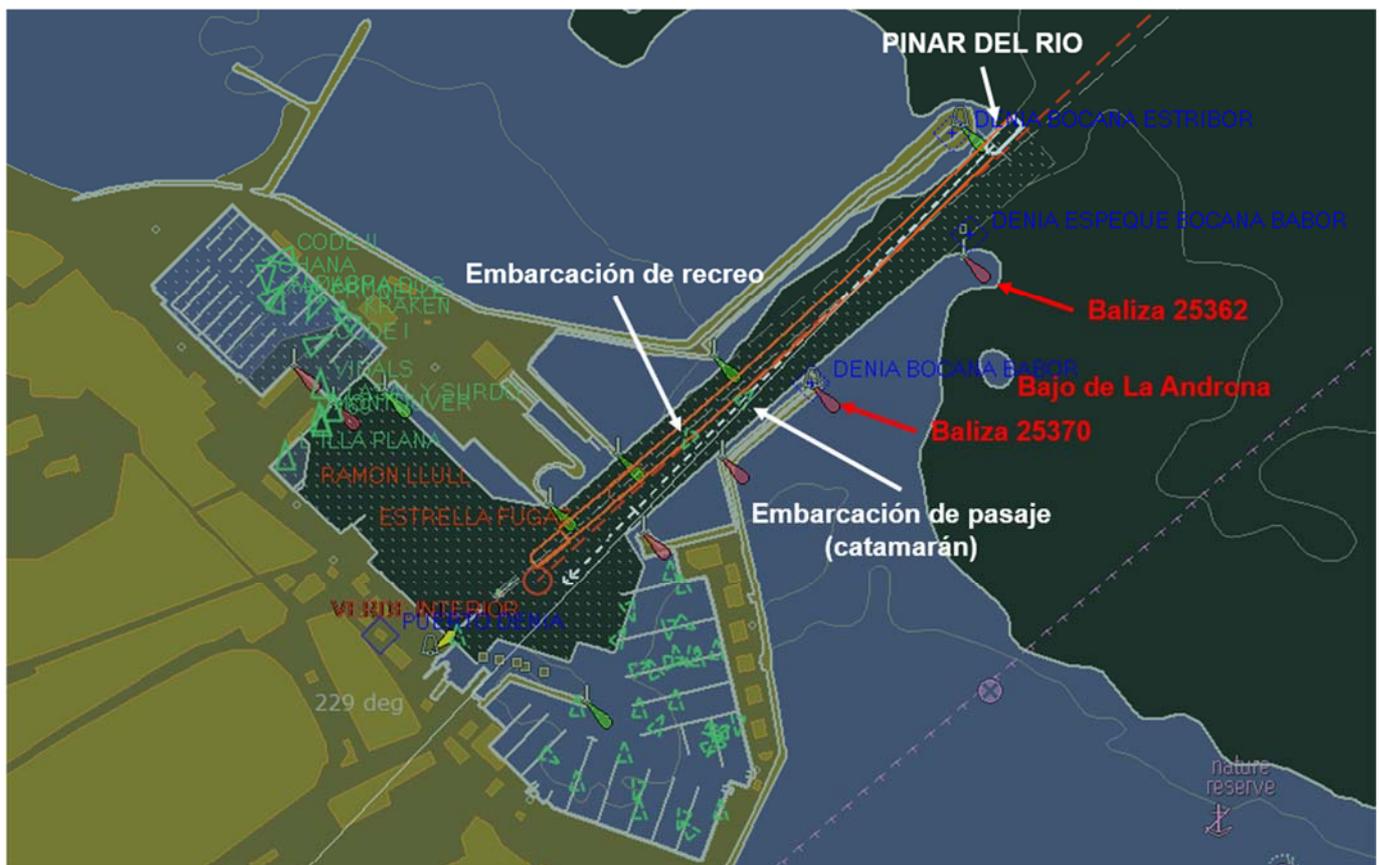
The captain of the ship PINAR DEL RIO clearly attempted to execute a manoeuvre that would minimise the risk of colliding with the departing catamaran, with sufficient time and staying as close as possible to the outer limit of the channel, as per rules 8(a) and 9(a) of the International Regulations for Preventing Collisions at Sea (hereinafter the Regulations). By focusing his attention on monitoring the catamaran's departure, he manoeuvred under the mistaken impression that he was sailing inside the channel when, in fact, the starboard hull was already outside its outer limit.

Figura 6. Screen capture of the ECDIS on the ship PINAR DEL RIO, at 23:16:16 hours [Source: Ship's VDR]

At the time of the grounding, the ship was sailing with a heading of 224.2° and a ground speed of 10.7 knots. The vessel's speed had been gradually reduced from the 29 knots it travels at in open water. Despite this still being a relatively high speed, vessels of this type, with low displacement and a large sail area, often approach the entrance channel at high speed to counteract drift and the loss of momentum caused by currents and changing wind directions so as not to lose their ability to manoeuvre. Hence the importance of ensuring the channel is clear when entering Denia's port (see Figura 6).

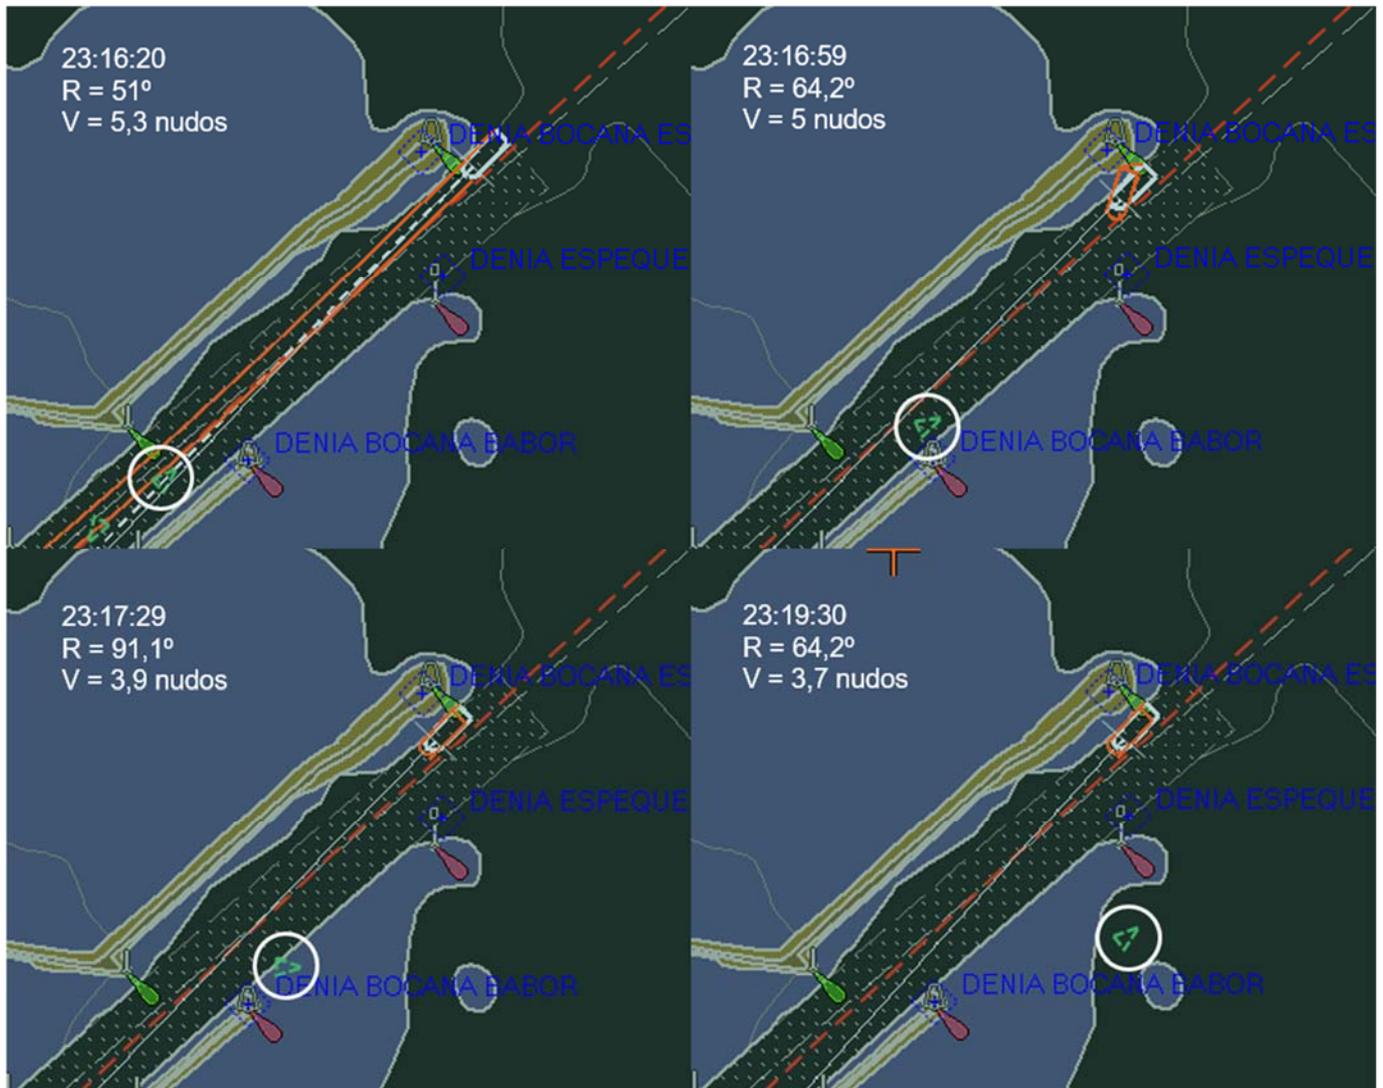
The ECDIS of both the ship PINAR DEL RIO and the CCS Valencia show that the MUNDO MARINO DOS catamaran sailed along the channel with a heading of 47.3° and a speed of 2.9 knots. At 23:16:20 hours, after the ship PINAR DEL RIO had run aground, the MUNDO MARINO DOS began to change course, falling to starboard and increasing its speed to 5 knots (see *figure 7*). At 23:16:59 hours, it passed and cleared the far end of the South Breakwater to fall further to starboard and exit the channel (see *figure 7*). Ultimately, the catamaran MUNDO MARINO DOS manoeuvred out of the port exactly as the captain of ship PINAR DEL RIO had anticipated.

By 23:17:29 hours, the catamaran was leaving the channel on a heading of 91.1° and with a speed of 3.9 knots, passing between the red sea beacon (25362) and the La Androna shallow.

Figura 7. The course followed by the MUNDO MARINO DOS catamaran [Source: VDR on board the PINAR DEL RIO ship]
