REPUBLIC OF TURKIYE
UNDERSECRETARIAT FOR MARITIME AFFAIRS
Marine Accident Investigation Commission

Report on the Investigation of The Fire Onboard

KAYHAN-9

Muğla / Nar Island
28 July 2010

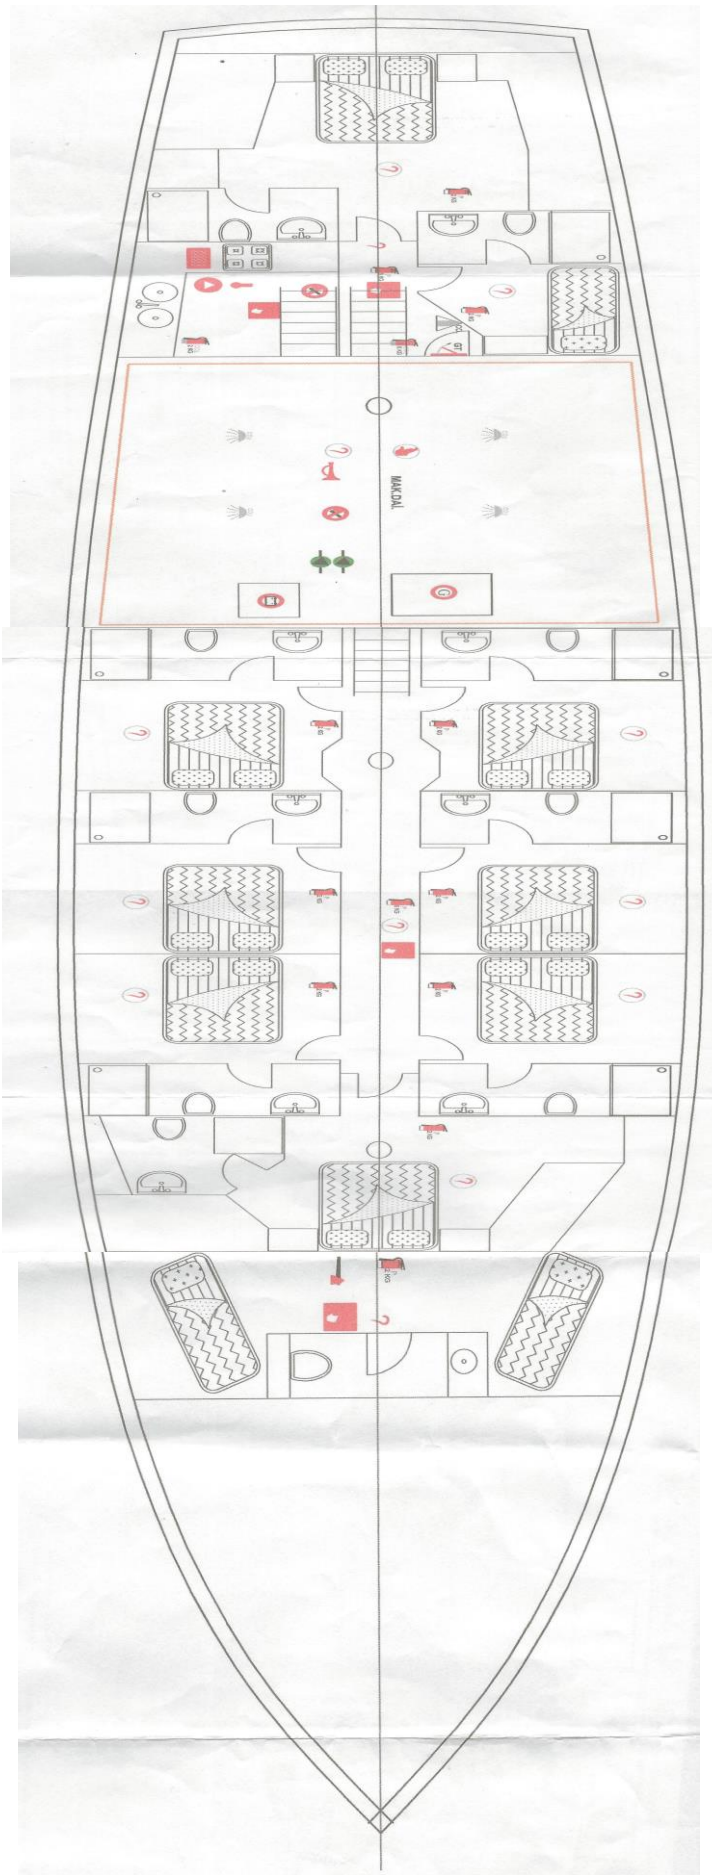
Picture 3: Fire safety plan

There were 2 fire pumps on board, one of which was in the engine room and the other one was in the forepart of the ship. A fixed fire-extinguishing system (Halocarbon), which was directed to the engine room, was also available. In addition, there are 15 portable fire-extinguishers with different types in the engine room and in the accommodation. The fire pumps could not be reached and used because of intense flames and heavy smoke. Therefore, the fire-fighting effort was only performed with portable-fire extinguishers. In addition, there were smoke detectors (fire detection system) in all cabins and in the engine room. However, the audio alarm devices were fitted on the detectors, and the system, which enables the alarms to be heard in the whole ship, was not available.

The National Technical Regulation of Vessels does not force the installation of fire detection system (smoke or heat detector) for the passenger cabins in the commercial yachts. In KAYHAN-9, the alarms were attached to the detectors, and the system, which enables the alarms to be heard in the whole ship, was not available. Therefore, the door of the cabin where the fire started was closed, and all the crew and passengers except one were above the deck so alarm sound could not be heard and caused a delay in the detection of fire.

4.1.1 Ensure that the wooden passenger ships to have a fire detection system in the passenger cabins and other closed areas as well as engine rooms. The administration should also ensure that the fire alarm could be heard in the whole ship.

4.2.4 Install a system to the entire fleet, which will enable the fire alarms to be heard in the whole vessels.

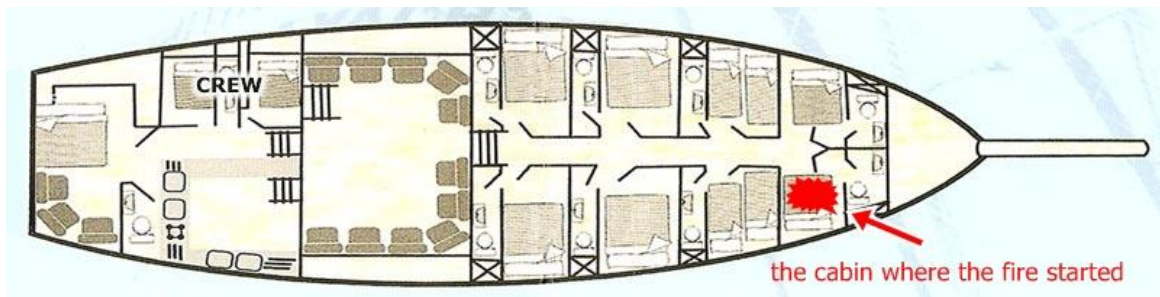
Picture 4: The location of the fire

KAYHAN-9 was totally burnt before sinking so that the ship could not be examined about the outbreak of the fire. By taking into consideration the visual statements of the crew and passengers, it is estimated that fire began in starboard side first cabin in the fore part of the vessel. It was a passenger cabin and there was nobody inside during the fire.

As it is hard to hear the alarm sound of the smoke detector outside the cabin when the door is closed neither crew nor the passengers alarmed. It is considered that probable causes of the fire are; a cigarette butt left in the cabin, an electrical device that was plugged in the cabin (e.g. a cellular phone or a battery charger) or a short circuit in a device or the electrical connections of a device that was installed in the cabin. None of them are proved but these were considered as potential causes of the fire.

On 25 July 2010 KAYHAN-9 anchored in a bay and received technical support for the malfunction of two of the Air Condition equipments found in two different cabins. The technical service team checked both of the air condition units and managed to repair the unit that was found in the cabin where the fire had started.

4.2.3 check all the electrical installations and equipment installed in the cabins of the entire fleet.

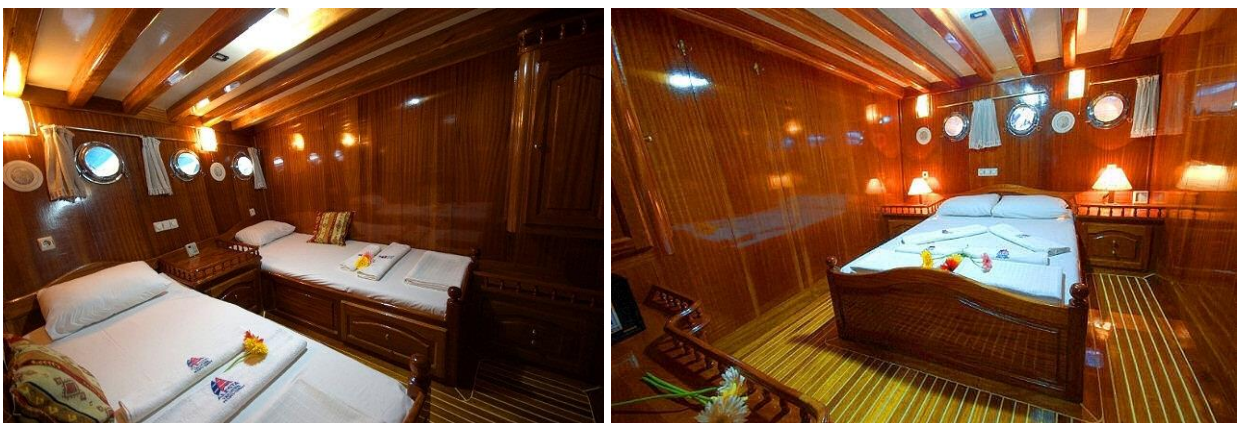
Picture 6: Fully varnished interior design

Because of the vessel was made of wood and completely varnished and there was a lack of an alarm system that can be heard from the main deck and bridge, the fire suppressed very fast, and a very thick smoke covered the entire vessel in a very short time. This caused panic and anxiety among the crew and the passengers.

3.2 Since the ship was made of wood and most parts were varnished, the fire started to spread rapidly, so the fire could not be taken under control.

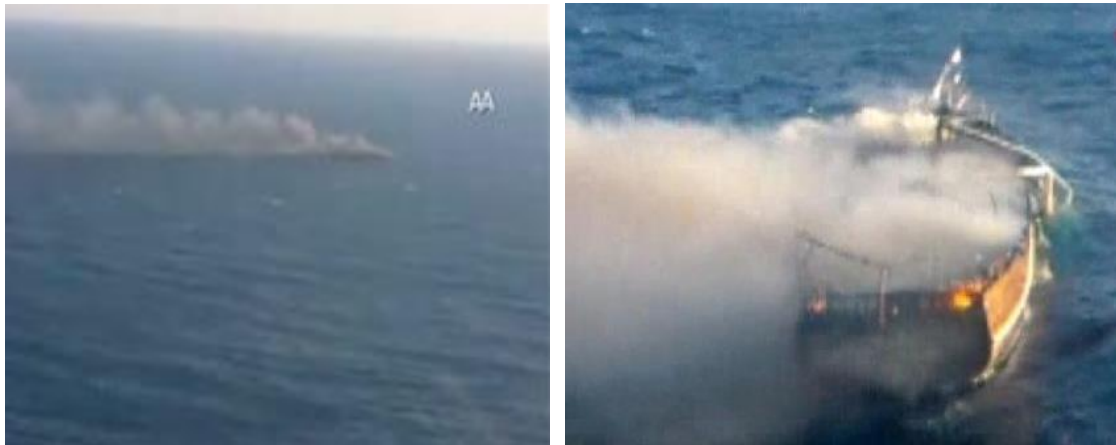
Picture 7: Aerial views during the fire

Since the ship was made of wood and most parts were varnished, the fire rapidly spread from the cab section into the lounge and spread up to the deck of the ship. The fire pumps, which are in the engine room and under the foreside of the yacht, could not be reached because of intense flames and heavy smoke. The fire-fighting effort was only performed with portable-fire extinguishers. However, they were inefficient in extinguishing the fire.

In the meantime, fire-fighting helicopter tried to extinguish the fire, but the effort was not sufficient to control the fire. As a result, yacht completely burned sank at 22:10.
