REPUBLIC OF TURKIYE
UNDERSECRETARIAT FOR MARITIME AFFAIRS
Marine Accident Investigation Commission

Report on the Investigation of The Fire Onboard

KAYHAN-9

Muğla / Nar Island
28 July 2010

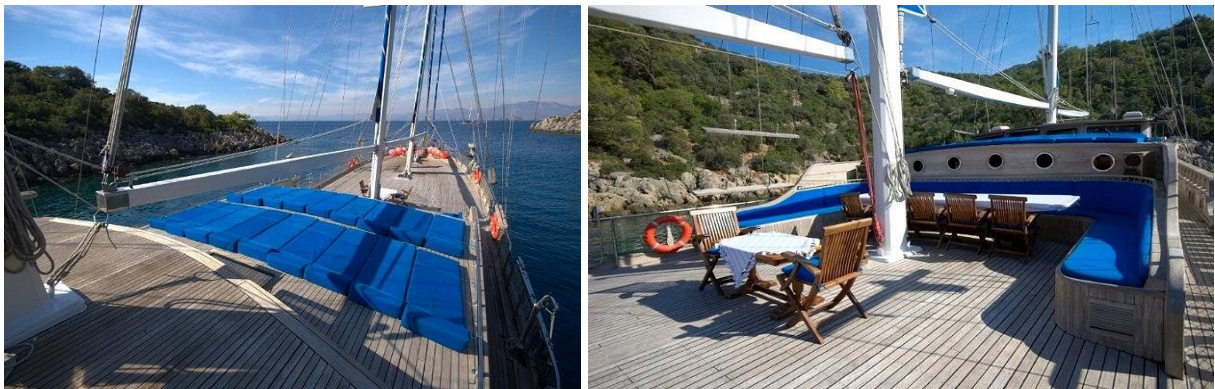
Picture 5: KAYHAN-9 main deck

KAYHAN-9 was totally burnt before sinking so that the ship could not be examined about the outbreak of the fire. By taking into consideration the visual statements of the crew and passengers, it is estimated that fire began in starboard side first cabin in the fore part of the vessel. It was a passenger cabin and there was nobody inside during the fire.

As it is hard to hear the alarm sound of the smoke detector outside the cabin when the door is closed neither crew nor the passengers alarmed. It is considered that probable causes of the fire are; a cigarette butt left in the cabin, an electrical device that was plugged in the cabin (e.g. a cellular phone or a battery charger) or a short circuit in a device or the electrical connections of a device that was installed in the cabin. None of them are proved but these were considered as potential causes of the fire.
